Storm damage on Black Rock Sea Wall, April 2009

Abstract

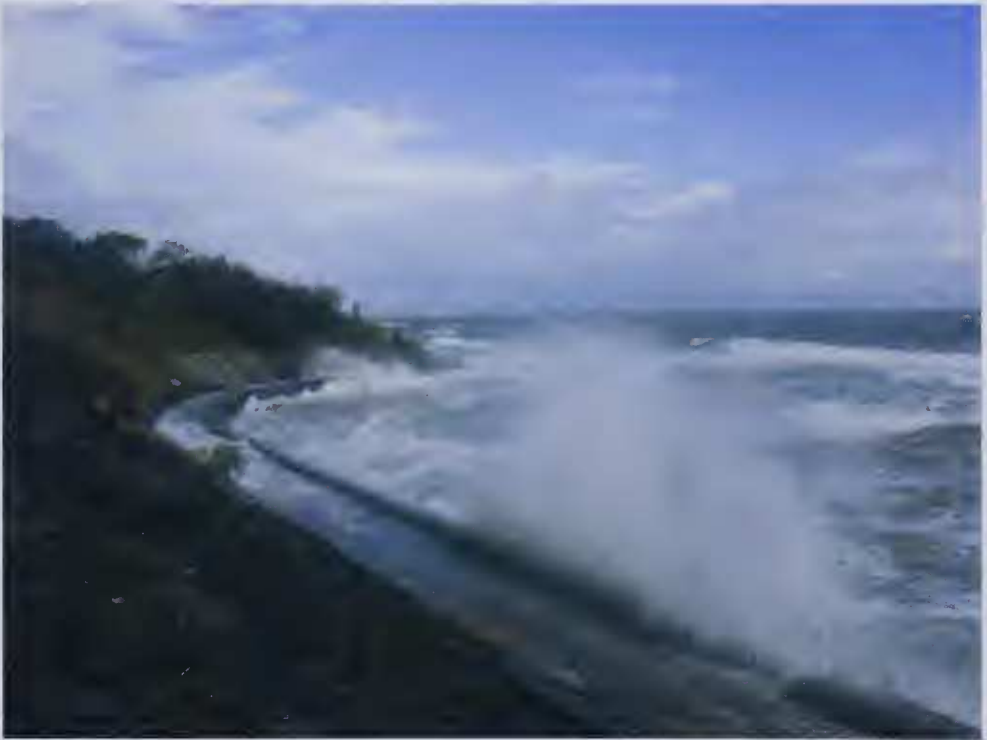
Fig. 3. Waves breaking over the sea wall at Quiet Corner on 26 April 2009.

A deep depression passed across southern Victoria on 25–26 April 2009, generating a south-westerly gale over Port Phillip Bay. For several hours, waves up to 2.5 m high broke heavily on the shore between Black Rock Point and

Quiet Corner (Fig. 3). In the northern half of the Black Rock beach compartment the waves broke on the seaward margin of the wide sandy beach and had little effect, the wave energy being absorbed by the sandy beach (Fig. 4). In the southern half a long sector of the sea wall (AB in Fig. 1) had no protective beach, and this is why the waves caused such severe damage (Fig. 5). Within a few days, southward drifting of sand began to build a beach in front of the damaged sea wall. By the end of May the sea wall was bordered by a narrow protective beach, and during the winter this became wider, until in November the wall was well protected (Fig. 6). Bayside Council decided to repair the sea wall and restore the features that existed prior to the storm, and this work was completed on 20 November.

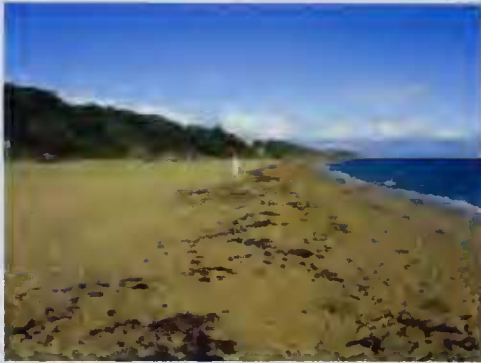
Fig. 4. The 26 April 2009 storm had little effect on the sandy beach north of Black Rock. Seaweed litter marks the limit of storm swash on that day.

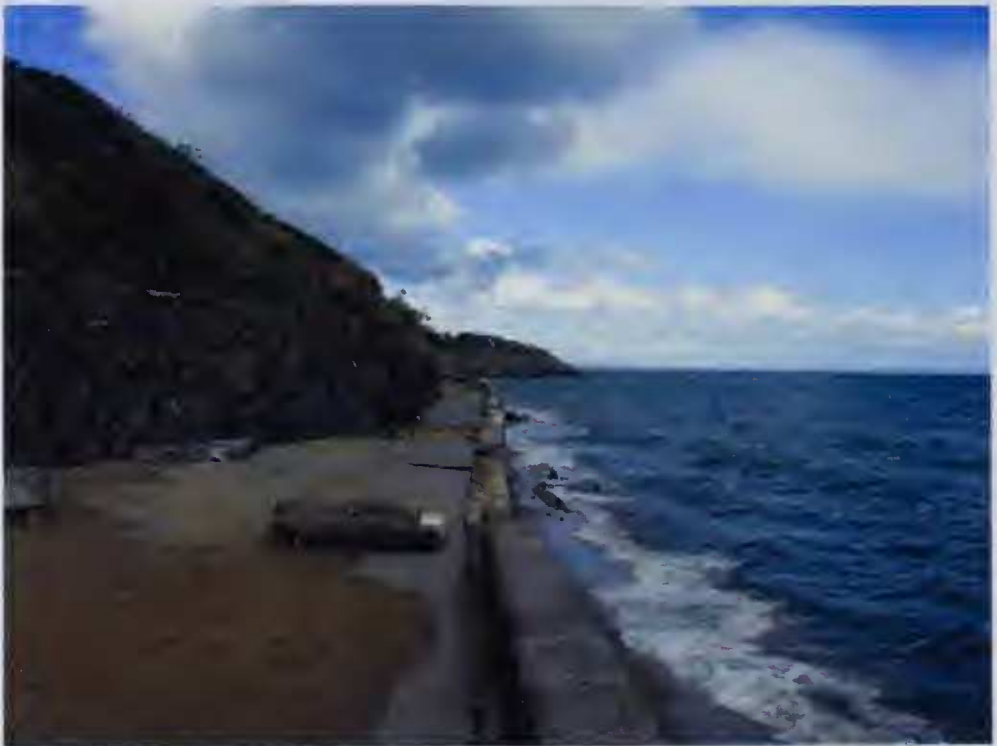
Fig. 5. Damaged sea wall south of Black Rock, 27 April 2009.

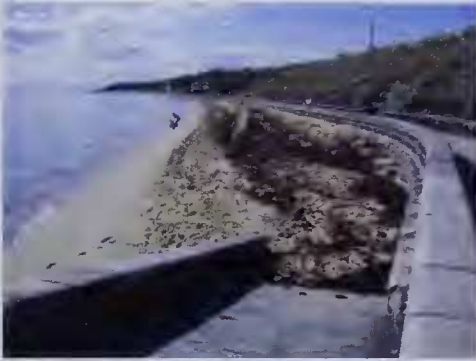
Fig. 6. Protective beach in front of sea wall south of Black Rock, November 2009.

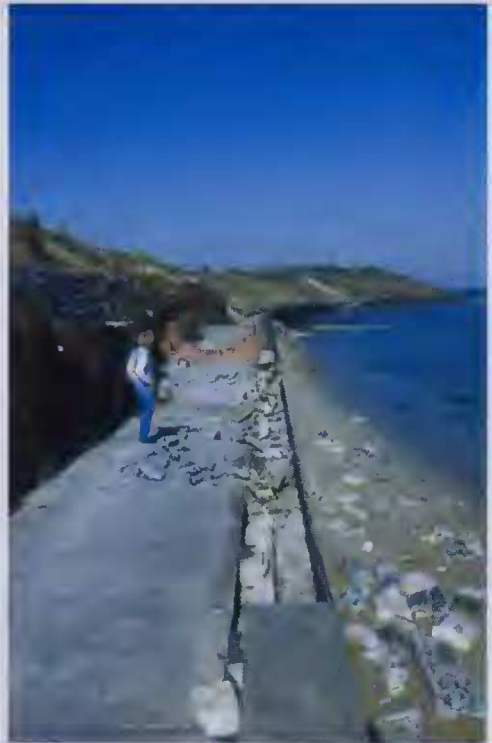
Fig. 7. Damage to sea wall by a previous storm, 30 April 1986.

The storm damage on 25–26 April 2009 was not unprecedented. There had previously been several episodes of storm damage, particularly in April and May, the time when there is little or no beach in front of the sea wall. The storm of 30 April 1986 inflicted similar damage (Fig. 7). The

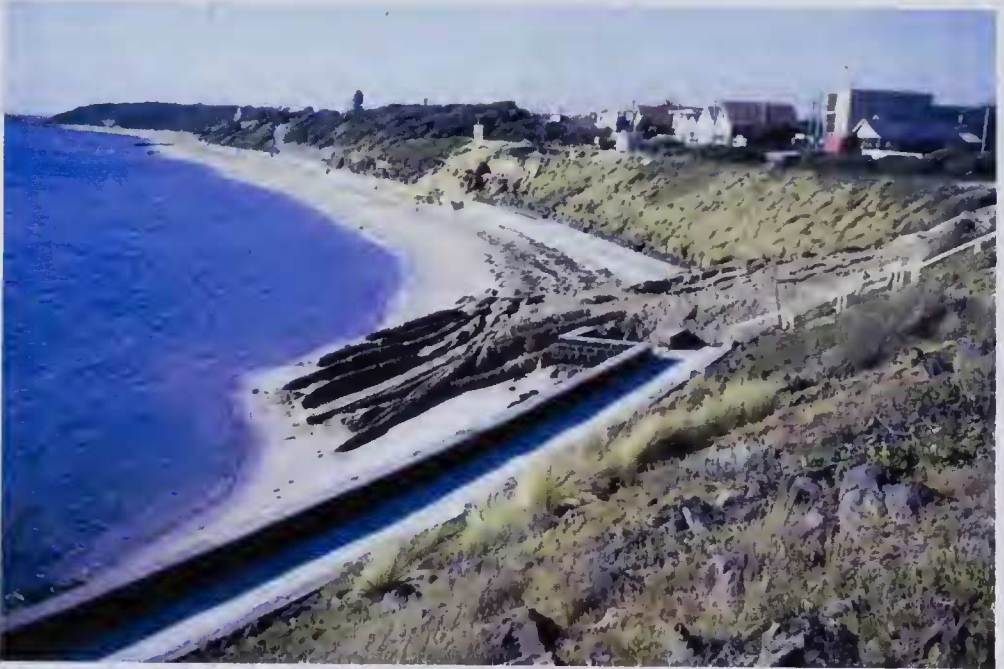
Fig. 8. Sand dumped on the shore near Quiet Corner, December 1969. It drifted away to the north during the next four months, and did not provide winter protection for the sea wall.

A previous attempt was made in December 1969 to maintain this beach by dumping numerous lorry-loads of sand in front of the sea wall (Fig. 8), but it all drifted away to the north during the following summer. It might be possible to maintain a beach here by dumping a very large quantity of sand (of the order of 200 000 m³), but there then would be losses northward (round Black Rock Point) when the
